South Park Bridge

Rehabilitation Feasibility Study

Technical Memorandum

prepared for:
King County Department of Transportation

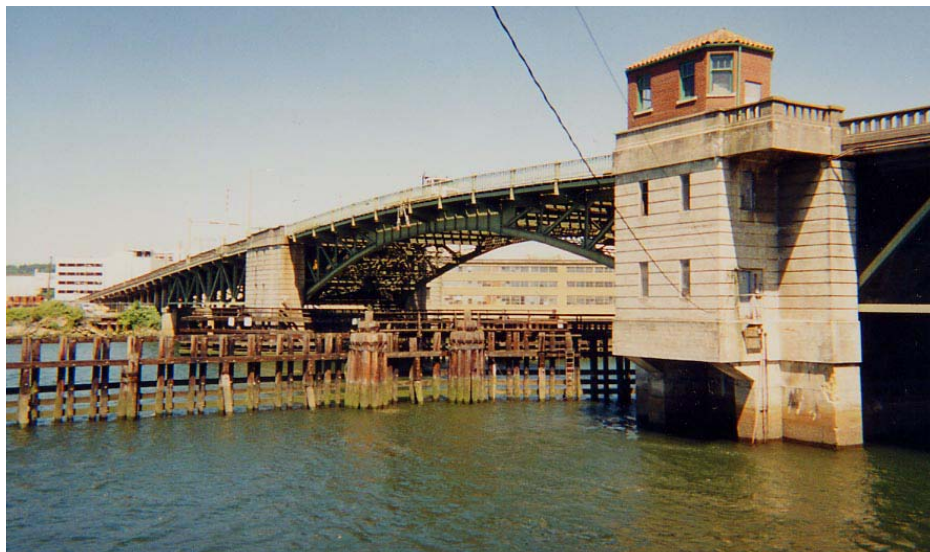
Photo 1: Current View of the South Park Bridge

The South Park Bridge (formerly called the 16th Avenue South Bridge) is a double-leaf bascule bridge built in 1931. Because it is the only operational example of a Scherzer rolling lift bascule bridge in the state of Washington, the bridge is listed on the National Historic Register [Refs. 22, 23]. See Photo 1.

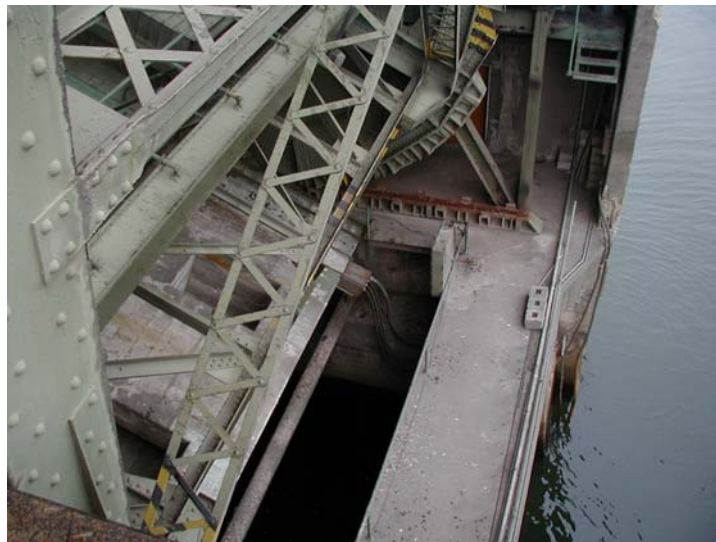
Photo 22: Existing Track Castings and Track Segmental Girders

The Stafford Engineering *In-Depth Inspection Report* of June 1992 [Ref. 51] reports that the bridge’s mechanical machinery has been well maintained over the years and is in generally good condition. Since Stafford Engineering’s previous inspection in November 1986, new traffic gates were installed and debris that fell through the roadway and collected on racks, tracks and track mounting flanges is being removed on a regular basis. Some debris still collects at the live load reaction points and horizontal tracks, but more frequent cleaning prevents further corrosion of mechanical components.

In 1995, King County made repairs to the mechanical components as per recommendations stated in the Stafford Engineering report of 1992 [Ref. 51]. The differentials and bearings were rebuilt. King County also implemented a regular greasing and lubing program in 1998, to lengthen the service life of the mechanical components.

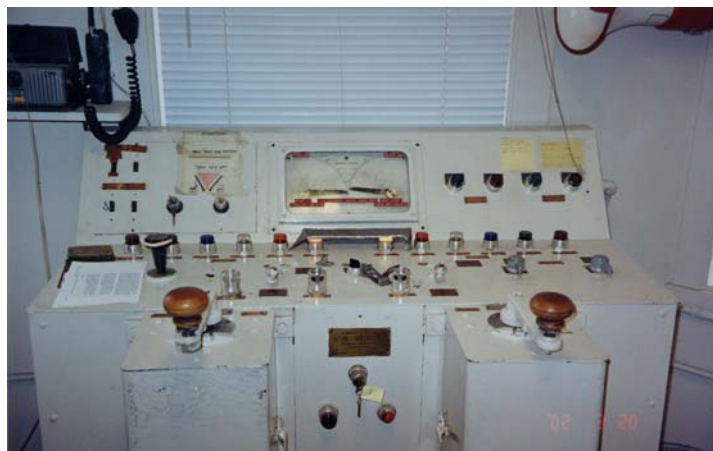
Photo 24: Original Control Desk

The controls for the traffic gates are not original. The control relays are mounted in a freestanding enclosure on the lower floor next to the generator control board. The cast-iron traffic gate housings are probably original. The interior operating machinery was replaced in 1989 with hydraulic operators.

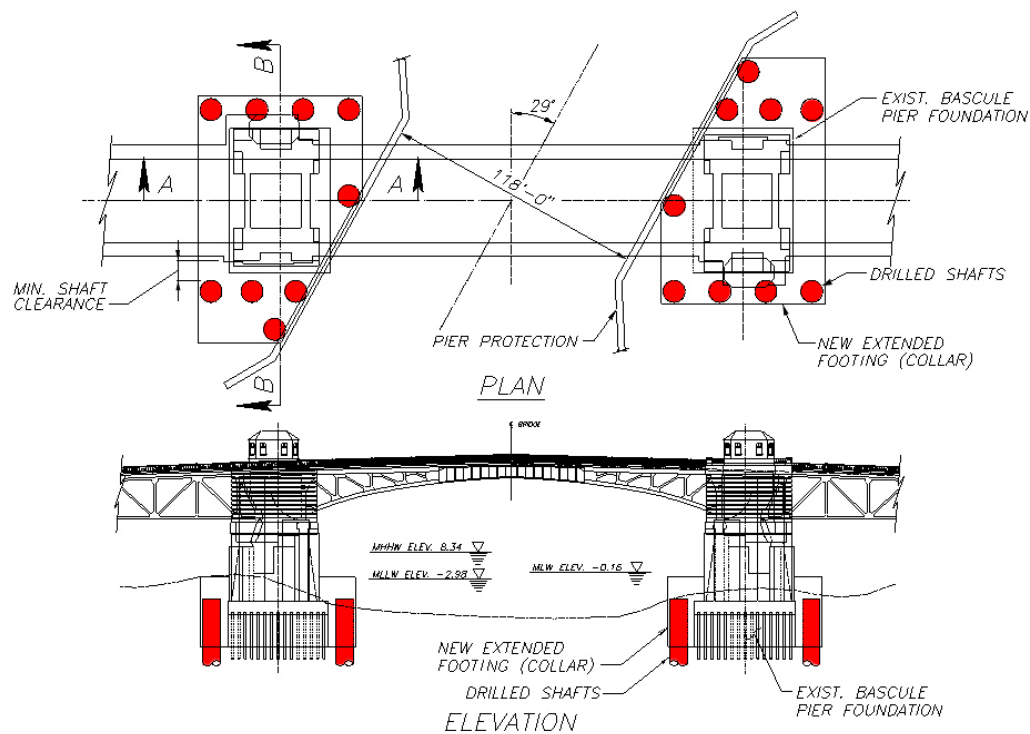
Figure 6: Bascule Pier Foundation – Rehabilitation Option 1 (Plan and Elevation)

The existing bascule pier foundations do not have sufficient vertical and lateral load resistance capacity if a major design level earthquake occurs. The potential foundation settlement and drift during an earthquake may damage the entire bridge beyond repair. A previous study recommended “provid[ing] new foundations to provide adequate vertical and lateral resistance” [Ref. 5]. However, the recommended “new foundations,” which were extensions to the existing foundation, would use four 6'-0" shafts (one near each corner of the existing footing), which would encroach into the existing navigational channel.

Based on this study, rehabilitation of the bascule pier foundations is proposed, in which seismic overturning and lateral forces would be mitigated through the addition of large diameter piles. In order to maintain the current 118 feet navigational channel width, irregularly shaped footing extensions, which would “collar” around the existing footings, were considered (see Figure 6). Preliminary calculations indicated that at least nine shafts of 10-foot diameter would be required at each bascule pier foundation to provide sufficient vertical load carrying capacity and lateral load resistance. It would be extremely difficult to place the two shafts along the bridge centerline adjacent to the north and south pier protection, because a hole would have to be cut in the bascule leaf and then repatched.

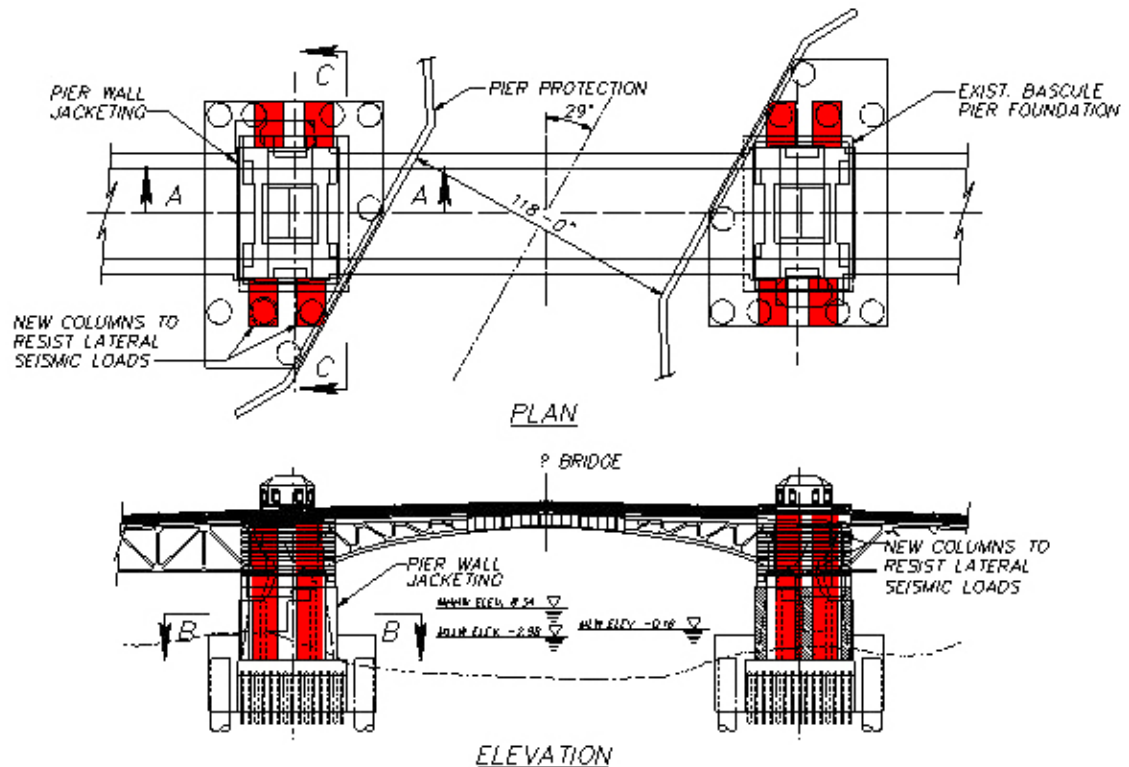
Figure 10: Bascule Pier Wall – Rehabilitation Option 1 (Plan & Elevation)

Vertical tie-downs and post-tensioning of the pier walls to the foundation, as previously proposed [Ref. 1], would not be sufficient to meet project requirements [Ref. 12]. If adequate pier rehabilitation is not implemented to provide confinement for the pier walls, the vertical and diagonal cracking would likely continue to worsen with the rolling action of the bascule girders and eventually the walls would fail due to shearing.

To mitigate cracking, differential movement, and splaying in the pier walls, PB investigated a “sandwich” rehabilitation solution. The feasibility of using a grillage of steel beams encased in concrete (with cathodic protection or coatings to prevent further acceleration of corrosion, etc.) both inside and outside the bascule pier walls is proposed to “sandwich” and confine the existing pier walls. See Figure 10.

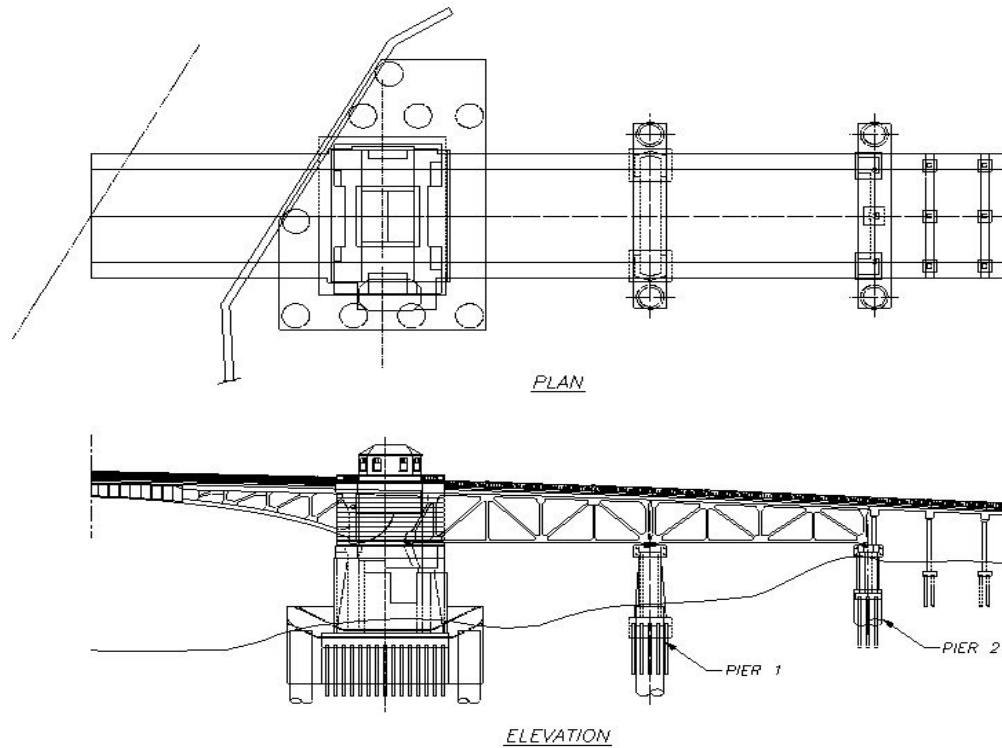
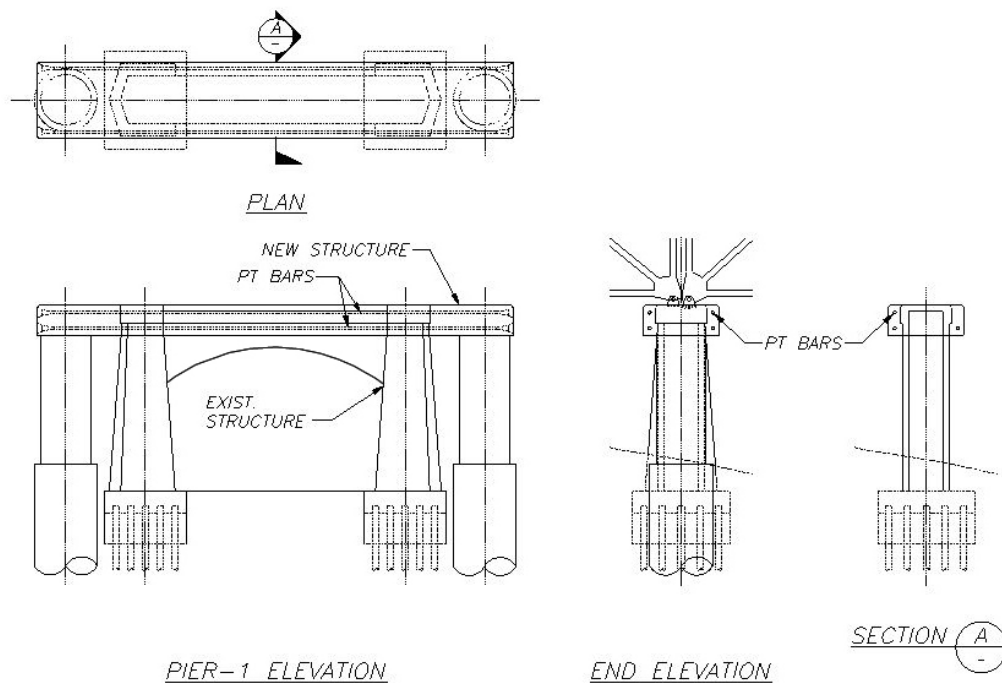
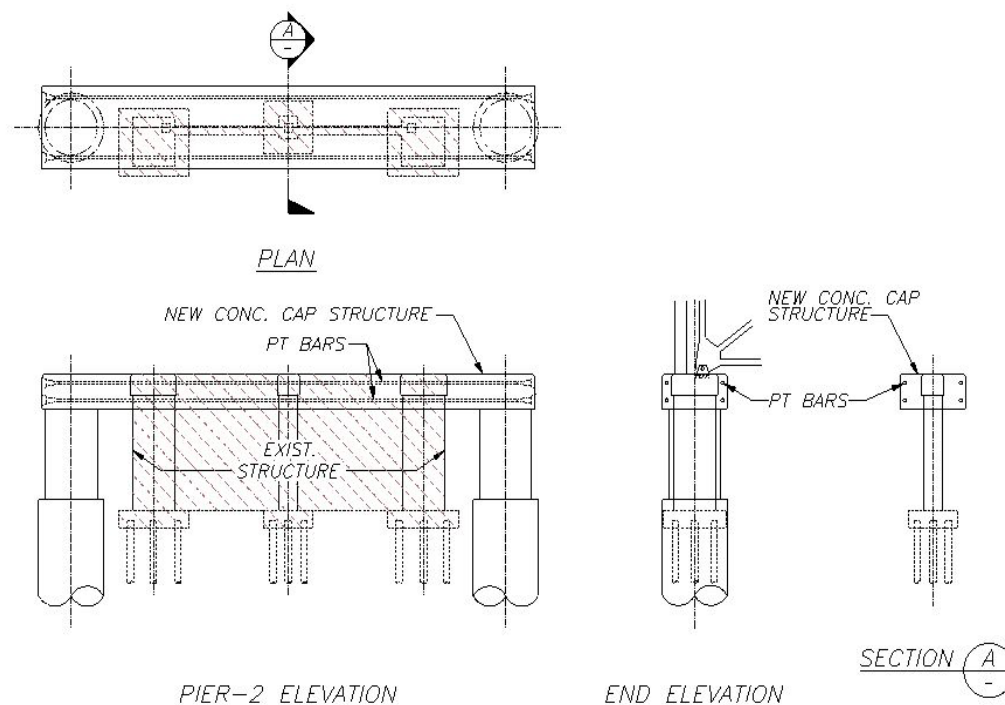
Based on the condition reports, the steel truss approach piers show significant deterioration above and below the waterline, including spalling, chloride attack [Ref. 18], and alkali-silica reaction. The condition of the timber piling is unknown [Ref. 4]. Preliminary review of the as-built drawings revealed that the piers are minimally reinforced and are not detailed for confinement and transfer of lateral loads, particularly large seismic forces. To resist lateral force during an earthquake, new pier columns supported by large diameter drilled shafts would be constructed adjacent to the existing piers and connected to the existing pier caps. The existing pier caps would be strengthened and post-tensioned. A new diaphragm wall would be constructed between the existing pier columns to resist lateral seismic loads during a major earthquake event. See Figures 13, 14, and 15.

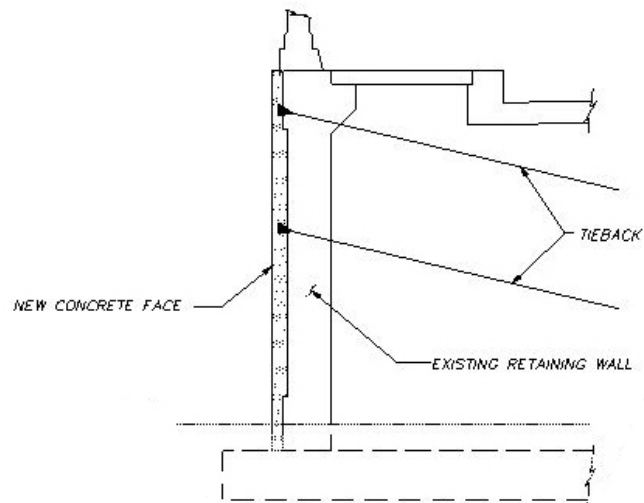
Figure 16: Retaining Wall – Rehabilitation Option 1

Retaining walls along the south approach were rotated and cracked during the Nisqually Earthquake. Tieback or soil nailing with a cast-in-place reinforced concrete face in front of the existing wall are recommended to restore the wall. See Figure 16.
